# Hotline info

Bilmerke:	Seat
Model:	Ibiza
Årsmode:	2014-
Km stand:	100.000 km +
Motorkode:	CFW?

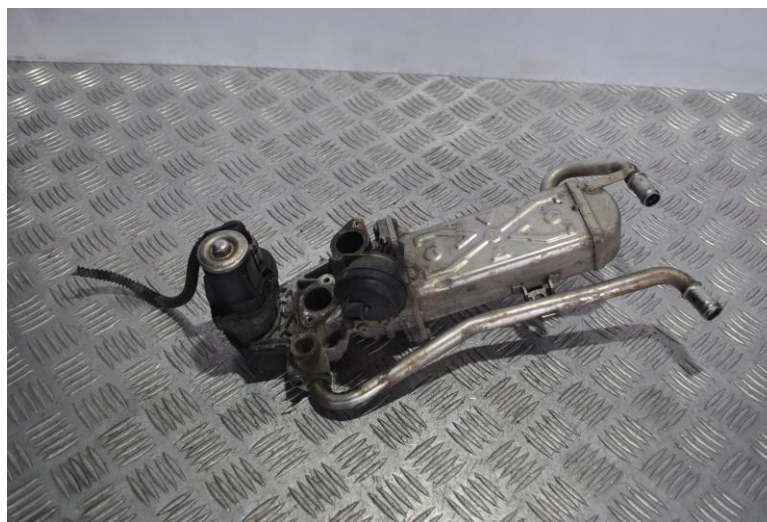
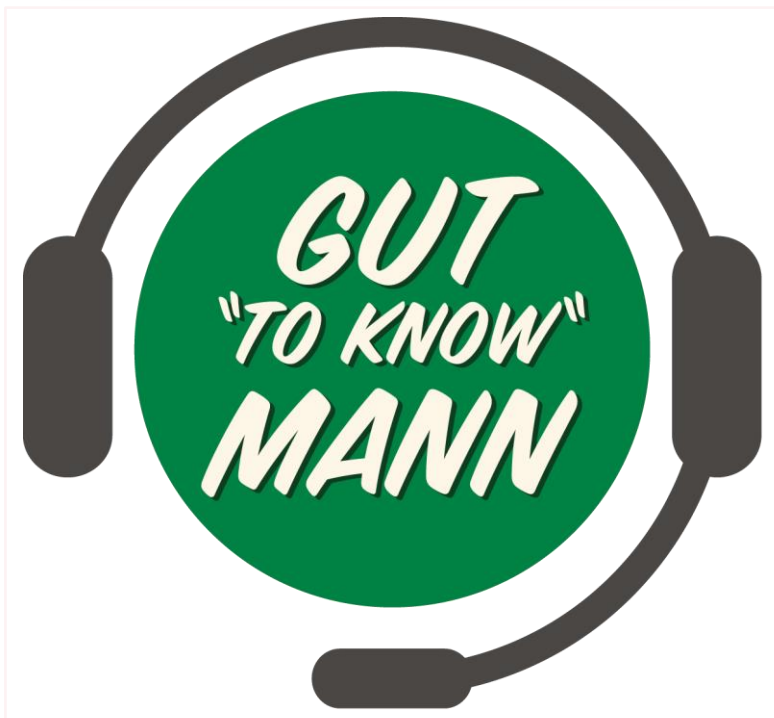
- EGR ventil defekt.
- Ventilen står konstant åpen pga. sot eller annen møkk, så motoren får falsk luft.
